# PERFORMANCE OF A MASONRY HOUSE CONSTRUCTED IN A LOW PRICE HOUSING PROJECT IN GUAYAQUIL - ECUADOR.

Jaime ARGUDO <sup>(1)</sup>, Ángel FUENTES <sup>(2)</sup> & Jaime GUAMÁN <sup>(2)</sup>

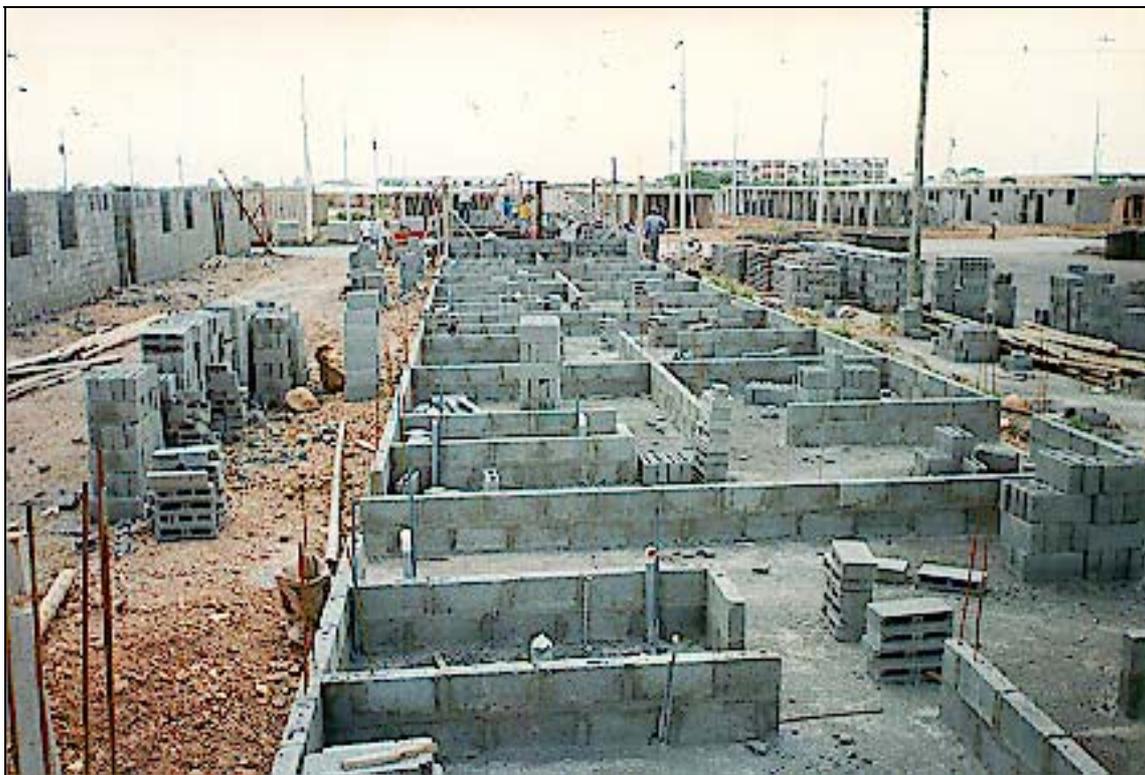
Photograph No. 1: Masonry houses constructed in the UST project.

The masonry house of UST project is shown in Photograph No. 1. It was constructed with the following materials:

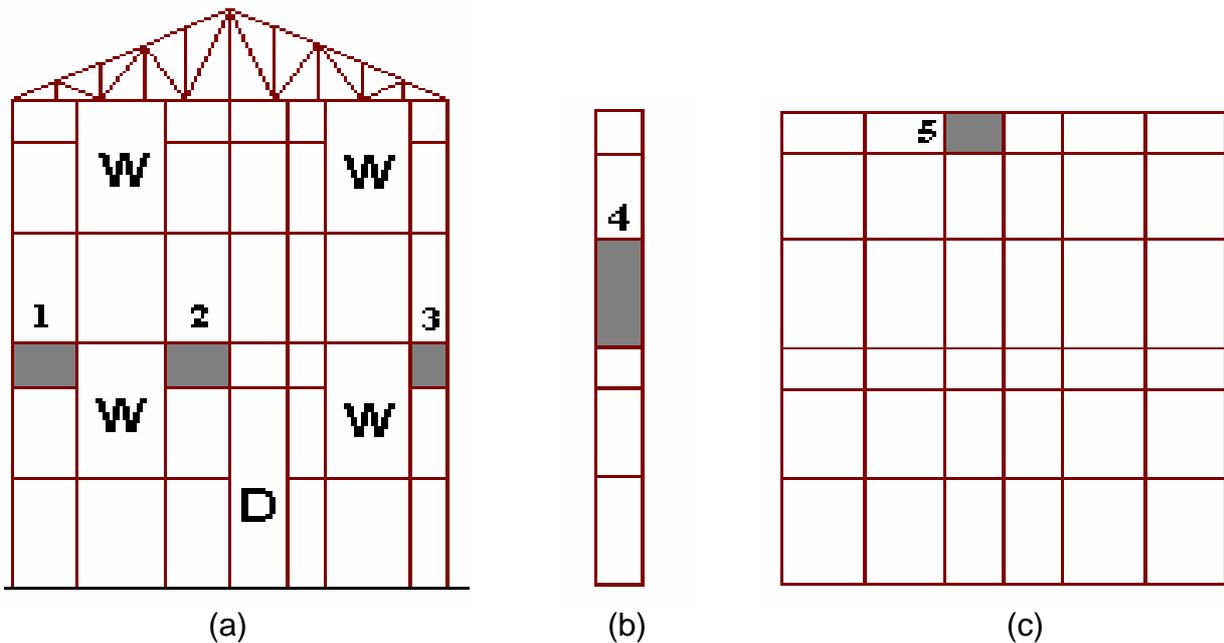
Figure No. 3: Critical elements at UST masonry house obtained from the shell analysed to study the structural behaviour.

Results from the analysis are presented in Table No. 3, for every critical element not satisfying the specified allowable stresses. Critical elements are shown in Figure No. 3. It was assumed a workmanship factor<sup>5</sup> equal to 0.5.

- (a) Three critical elements located at the front similar to others at the back wall will experience severe local damage due to the lack of a heading beam.
- (b) Internal wall at the bathroom needs reinforcement.
- (c) At the lateral walls a critical element is located at the top of the second floor. This is because the model does not consider a connection between roof and walls. The roof should restrain the walls.

In conclusion, few elements will experience severe damage during an ultimate design earthquake. The structure will reach inelastic behaviour but will not collapse<sup>4</sup>. This is considered normal.

To reduce damage in critical elements and to improve the original design in order to keep the structure within the elastic range some countermeasures are recommended<sup>4</sup>.

- a) Increase the diameter of vertical bars up to 10 mm at the front and back facades
- b) Place one 8 mm bar at the bathroom wall to reinforce that area
- c) Place a 900x200 mm beam reinforced with two 8 mm bars at the head of the windows and doors in the front and back facades to prevent the failure of panels 1, 2, and 3, which are subjected to large bending stresses.
